# Greenville Overlook

## Environmental Daily Status Report

**BrightFields, Inc.**  
Environmental Services

**Date:** 8/13/08

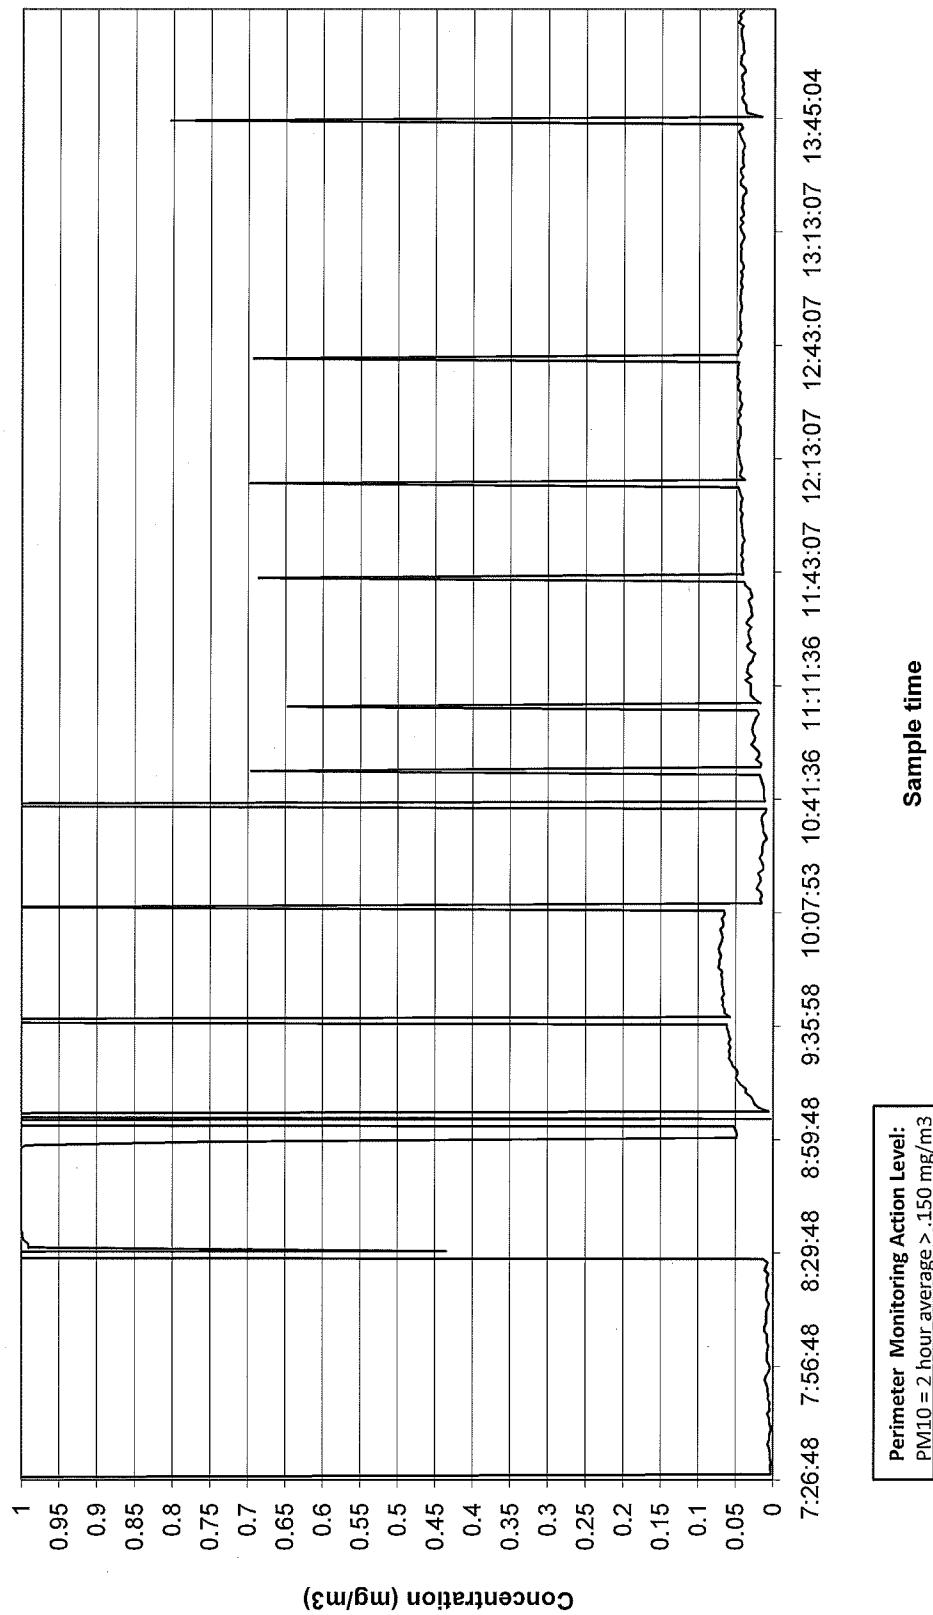
**Concentration Vs. Sample Time  
Perimeter Dust Meter Location 5  
8/13/08**

Data reported at location #5 includes spikes which occur in a rhythmic pattern apparently related to the measuring device itself. There were not sustained readings above action levels. The meter location was away from construction activity further supporting that the readings were not indicative of dust generated from construction.

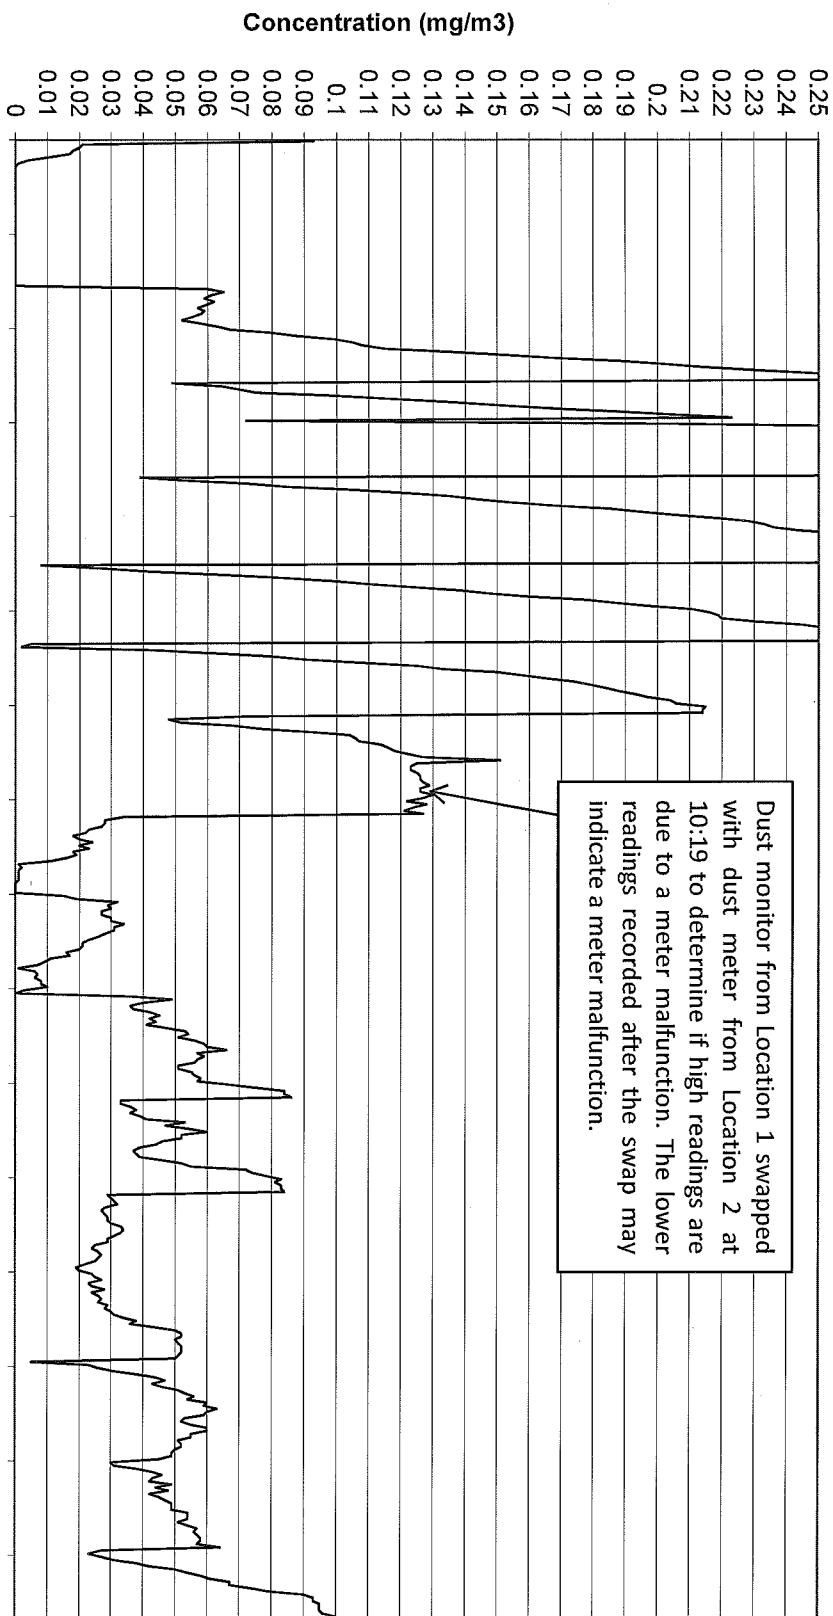
**Concentration Vs. Sample Time  
Perimeter Dust Meter Location 1**

DNREC was notified that the action limit for perimeter dust was exceeded at monitor Location 1 (north location). The majority of construction activity at the time of exceedance consisted of spreading stone from an off-site source. The dust monitor from Location 1 swapped with dust meter from Location 2 at 10:19 to determine if the elevated readings were due to meter operation. Lower readings were recorded at Location 1 after the swap which may indicate a meter malfunction. The meter will be inspected and serviced if required.

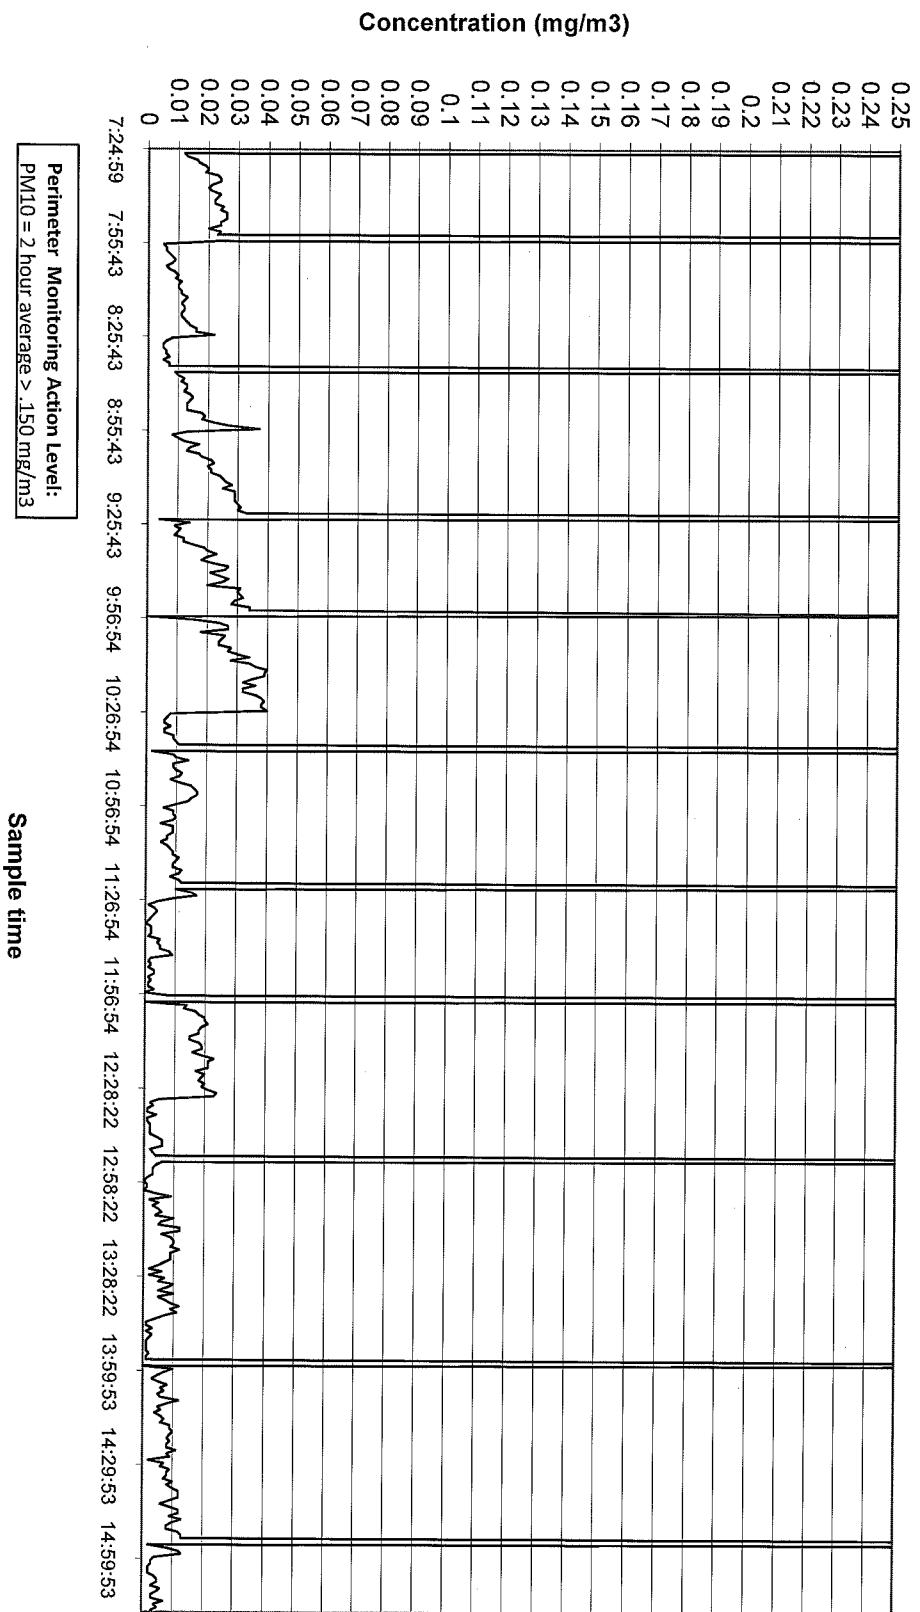
**Concentration Vs. Sample Time  
Perimeter Dust Meter Location 5  
8/14/08**

Data reported at location #5 includes spikes which occur in a rhythmic pattern apparently related to the measuring device itself. There were not sustained readings above action levels. The meter location was away from construction activity further supporting that the readings were not indicative of dust generated from construction.
